INSPECTOR GENERAL

AUGUST 13, 2015

Continental United States Military Housing Inspections— National Capital Region

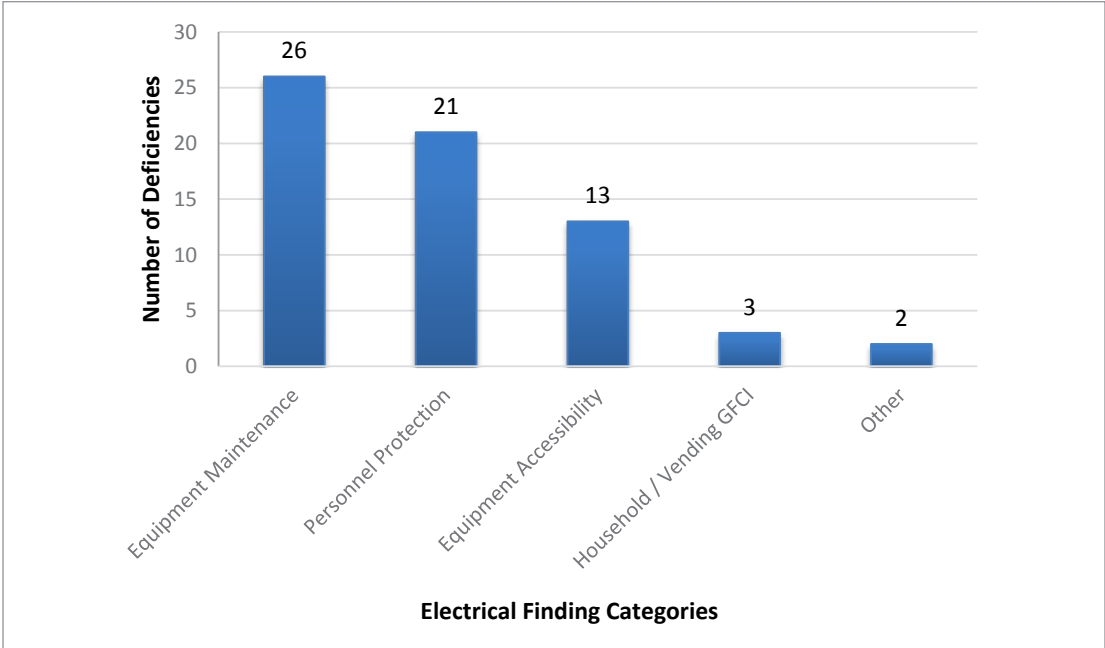
Figure 2. USAG Fort Belvoir Electrical Systems Deficiencies

We identified 65 electrical system deficiencies for both accompanied and unaccompanied housing units. We grouped them into five categories (see Figure 2). The majority of deficiencies for both accompanied housing and unaccompanied housing were in relation to equipment maintenance, personnel protection, and equipment accessibility. NFPA 70, “National Electrical Code,” defines personnel protection as “a system of devices and constructional features used together to protect against electric shock of personnel.” Equipment maintenance examples included conduits not properly supported, electrical panel schedule not labeled correctly, and electrical wires not terminated properly. Personnel protection examples included missing electrical box panel covers and knock-out seals, and unrated ceiling fan boxes. Equipment accessibility examples included blocked electrical panel access and a broken electrical panel door closing and opening mechanism.

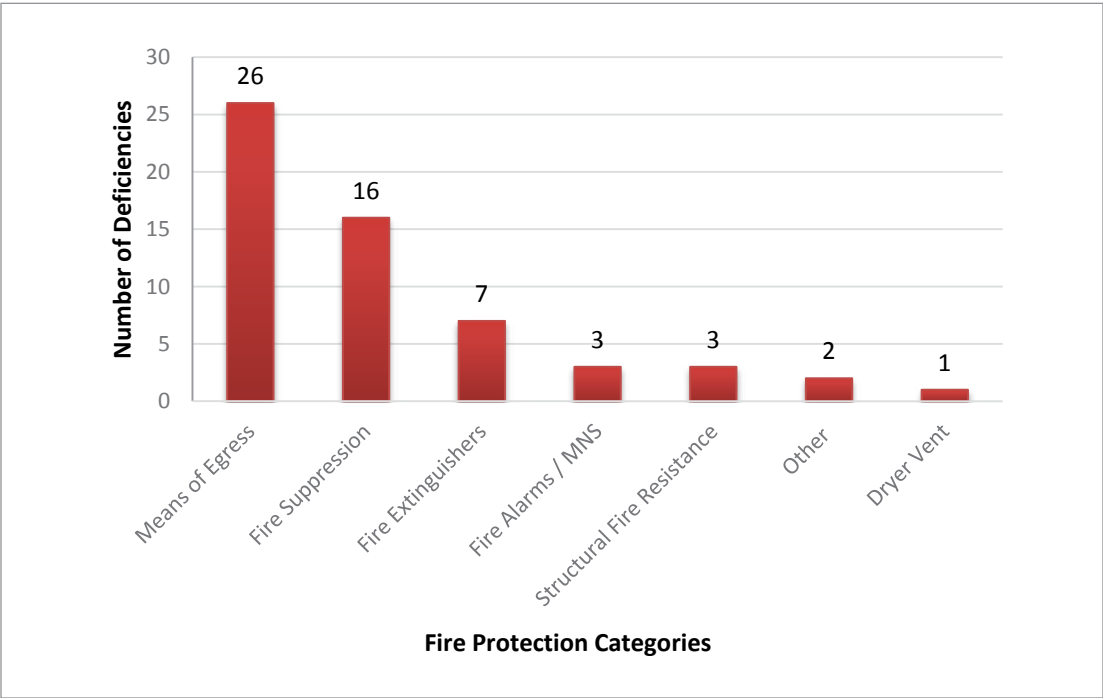
Figure 5. USAG Fort Belvoir Fire Protection Systems Deficiencies

We identified 58 deficiencies related to fire protection systems which are grouped in 7 categories (see Figure 5), with the majority of deficiencies found in unaccompanied housing. Means of egress and fire suppression had the most deficiencies in the fire protection categories. Some examples of means of egress included no secondary means of escape, handrails that were not contiguous, and inadequate exit signage. Some examples of fire suppression included sprinkler protective covers that were not removed, missing sprinklers, and fire doors propped open with missing closing/latching hardware.

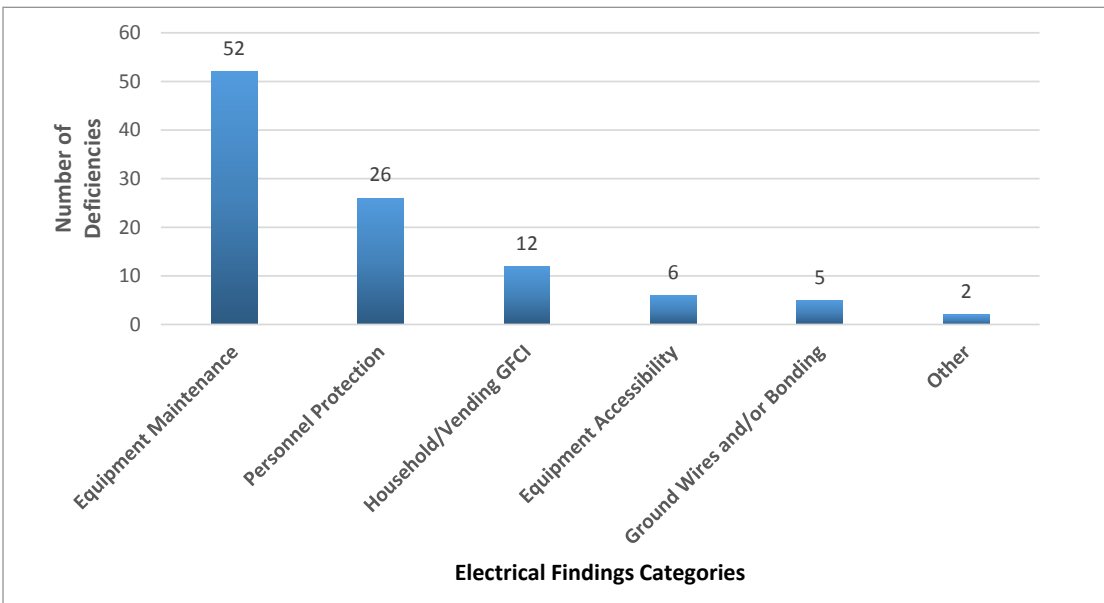
Figure 9. JBAB Electrical Protection Systems Deficiencies

The team identified 103 electrical protection deficiencies in both accompanied and unaccompanied housing. We grouped them into six categories (see Figure 9). As shown in Figure 9, the majority of deficiencies were in relation to equipment maintenance, personnel protection, household/vending GFCI, equipment accessibility, and ground wires and/or bonding.

Equipment maintenance examples included conduits not properly supported, electrical panel schedules not labeled correctly, and electrical wires not terminated properly. NFPA 70 defines personnel protection as “a system of devices and constructional features used together to protect against electric shock of personnel.” Personnel protection examples included missing electrical box panel covers and knock-out seals, and unrated ceiling fan boxes. Household and/or vending GFCI examples included GFCI outlets not being used in the required locations such as garages, kitchens, and bathrooms. Equipment accessibility examples included access to electrical panels blocked and inadequate work

space around electrical panels. Ground wires and/or bonding examples included ungrounded electrical switches and outlets, and neutral and ground wires not bonded at main electrical panel.

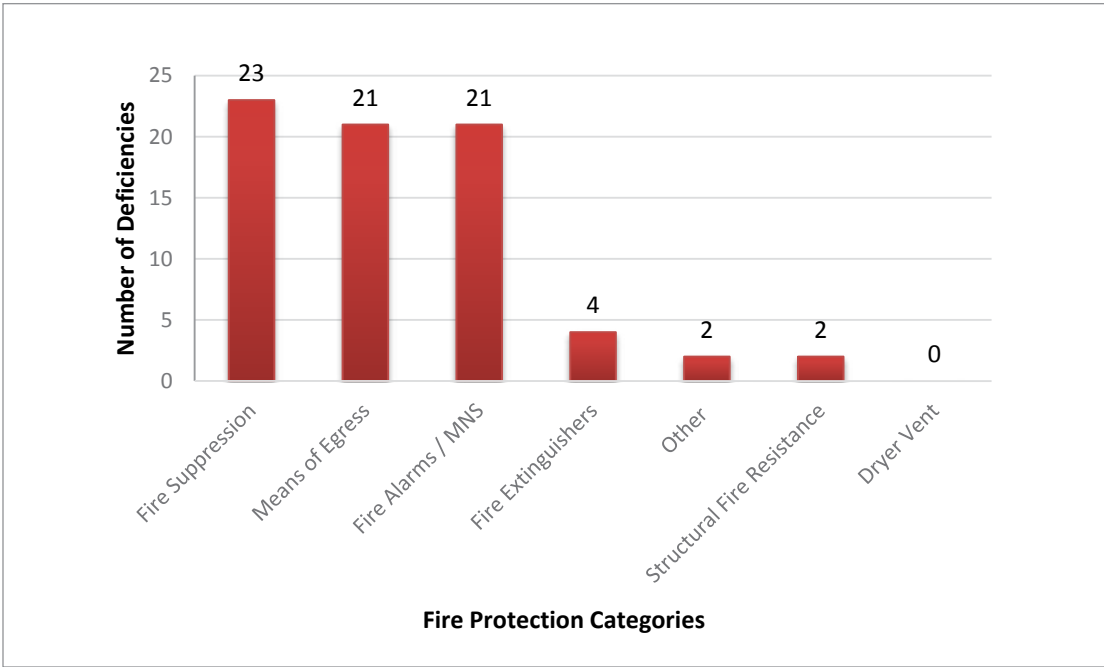
Figure 12. JBAB Fire Protection Systems Deficiencies

We identified 73 deficiencies related to fire protection systems and grouped them in 7 categories (see Figure 12), with the majority of deficiencies found in the barracks and BOQs. The accompanied family housing issues were also a concern and are also discussed separately.
